SAFETY AND FACILITIES PLANNING

Scott Landrigan 04-09-18

Facilities planning

WSD Facilities Plan

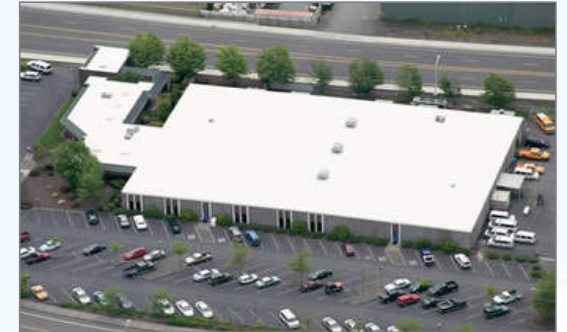
TPO
Thermoplastic Polyolefin
Plastic/rubber with filler
(Heat-welded seams)

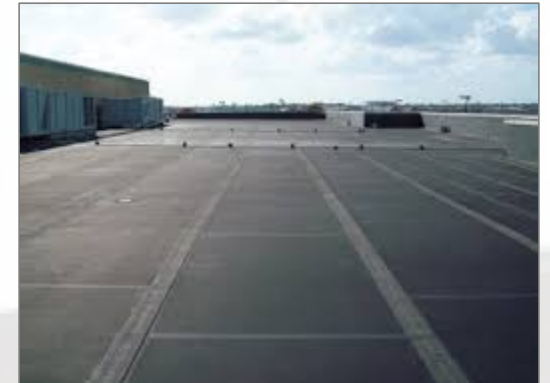
PVC
Poly vinyl chloride
(Heat-welded seams)

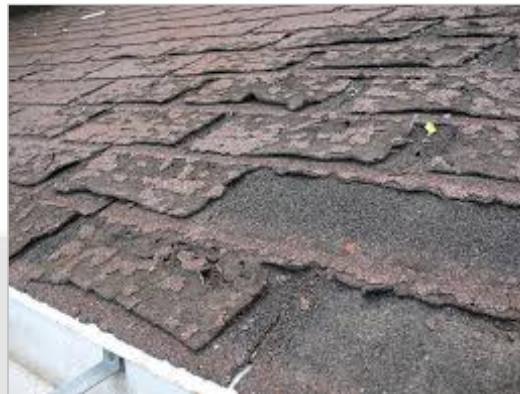
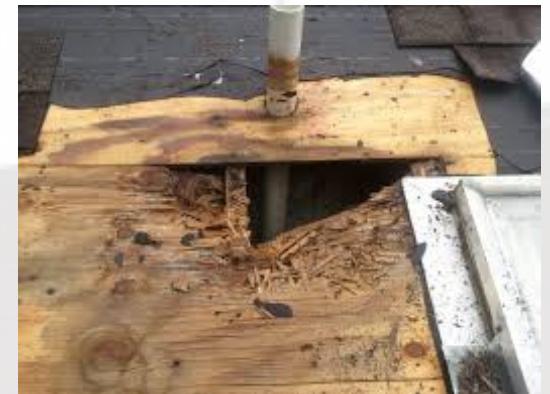
- Roof life expectancy and influences
 - Type of material
 - Weather
 - Pitch
 - Age
 - Facing direction
- Location of insulation
 - Energy code compliance
- Full rip off vs. cover
 - Asbestos concerns on older schools
 - Energy code requirements
 - Number of existing layers

- Alternate options to extend existing systems
 - Roof coatings
 - Must have suitable decking and structure
- Cost of delaying
 - Mold
 - Compromised decking
 - Structural Failure

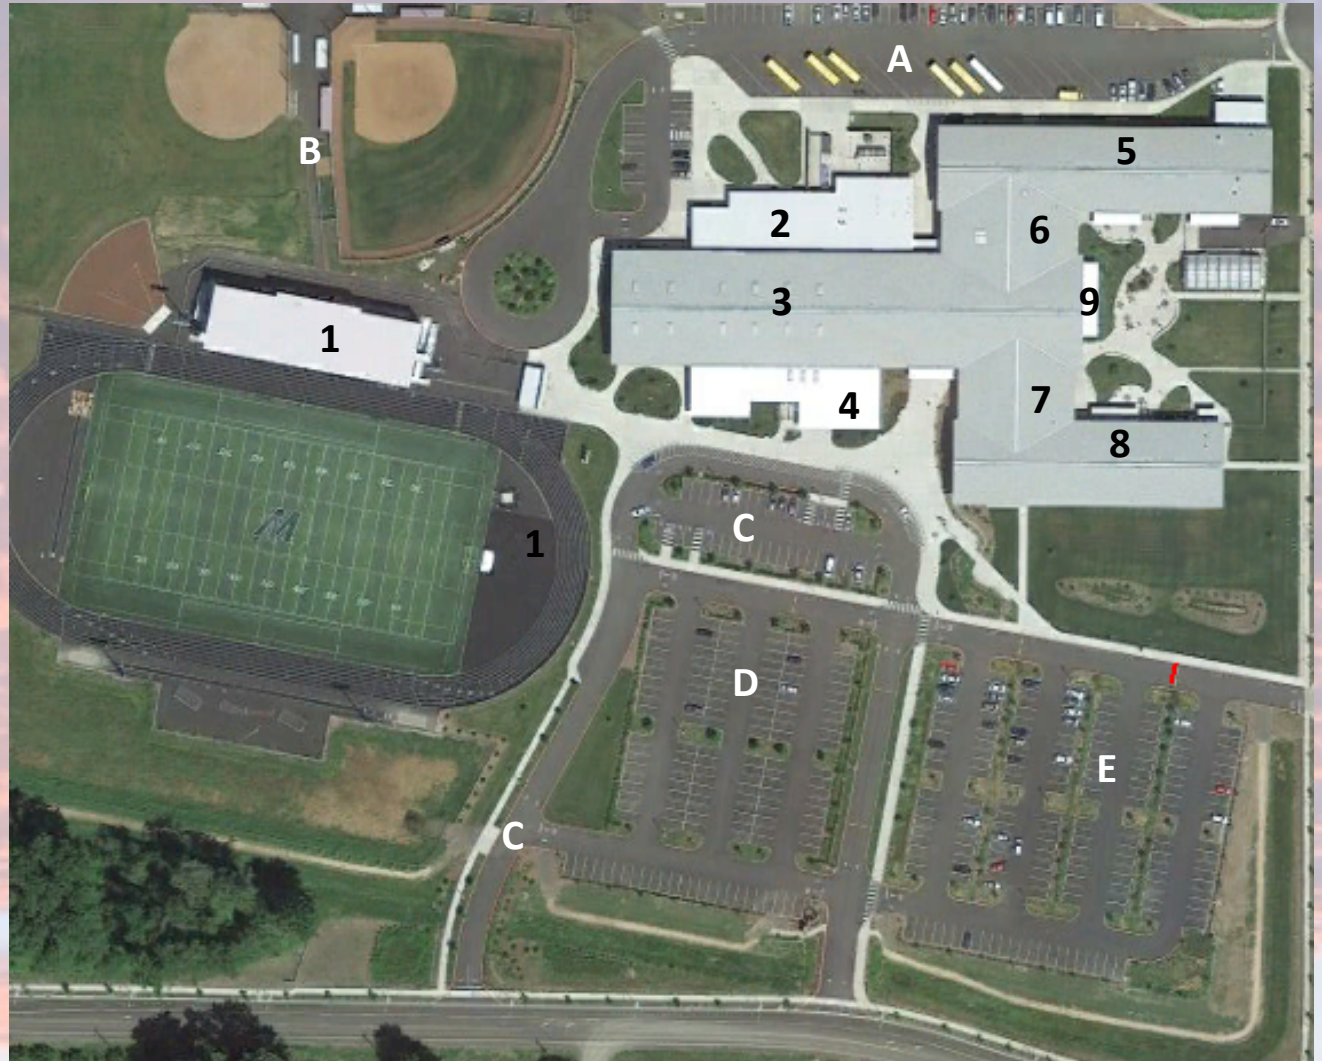
Roof and Blacktop Map

- 1 Stadium
- 2 Locker room
- 3 Gym
- 4 Spin/weight Room
- 5 Classroom wing north
- 6 Classroom bridge north
- 7 Classroom bridge south
- 8 Classroom wing south
- 9 Entrance awnings (7 installations)

- A North parking
- B Sport fields and approaches
- C Gym and exit rd.
- D Main Parking west
- E Main parking east

Name /Area	Sqft.	Type	Grade (key below)	Remaining Life	Cost (NA if past 10 years)	Expect Replacement Date	Note
Stadium	11,700	Metal	A	92.5%	N/A	30-50 year (40)	
Locker Room	10,250	Metal	A	92.5%	N/A	30-50 year (40)	
Gym	49,675	Composition	A	92.5%	N/A	22 year	
Spin/Weight Room	7,000	Metal	A	92.5%	N/A	30-50 year (40)	
Classroom Wing North	26,426	Composition	A	88%	N/A	22 year	
Classroom Bridge North	5,720	Composition	A	88%	N/A	22 year	
Classroom Bridge South	6,435	Composition	A	88%	N/A	22 year	
Classroom wing South	21,450	Composition	A	88%	N/A	22 year	
Entrance Awnings	1,800	Metal	A	92.5%	N/A	30-50 year (40)

Name /Area	Sqft.	Current Type	Grade	Cost of Repair sqft.	Extended Cost	Note
North parking lot	89,785	Blacktop	A	.36	\$32,322	Sealcoat/stripe/repared 2020/2025
Sports field and stadium approaches service rds.	40,500	Blacktop	A	.36	\$14,580	Sealcoat/stripe/repared 2023/2028
Gym parking and exit road	82,500	Blacktop	A	.36	\$29,700	Sealcoat/stripe/repair 2022/2027
Main parking west and entrance rd.	62,000	Blacktop	A	.36	\$22,320	Sealcoat/stripe/repair 2021/2026
Main parking east	64,980	Blacktop	A	.36	\$23,392	Sealcoat/stripe/repair 2021/2026
