Woodland Public Schools

Facilities and Safety Report

May 2019

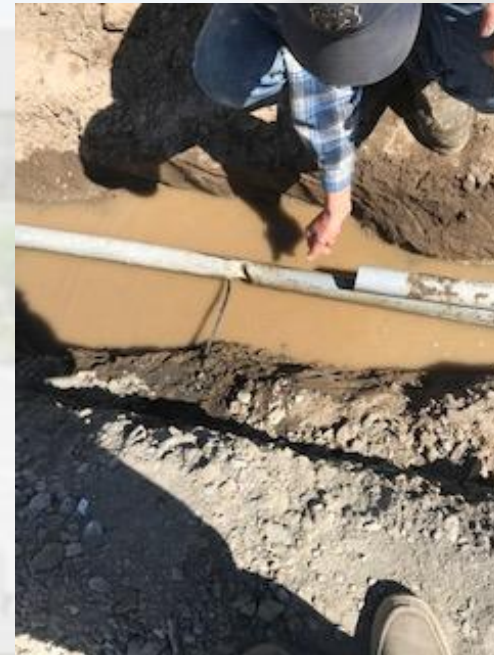
We spent a couple of days trying to figure out why the conduit between the district office and Columbia Elementary had collapsed. The source of the problem turned out to be a substandard installation of a phone line. The utility company that installed it (still trying to figure out who) crushed the spare conduit and intercepted our fiber optic conduit. They poorly cut a hole in it and ran their phone wire in the fiber optic conduit to the underground vault. This conduit runs around 600 feet and is the fiber optic lifeline to Columbia Elementary School and KWRL.

Picture shows section of pipe that had to be replaced (top pipe) and Fiber optic conduit that was cannibalized by utility company
